Proper Preservative Treatment Prevents Premature Failures

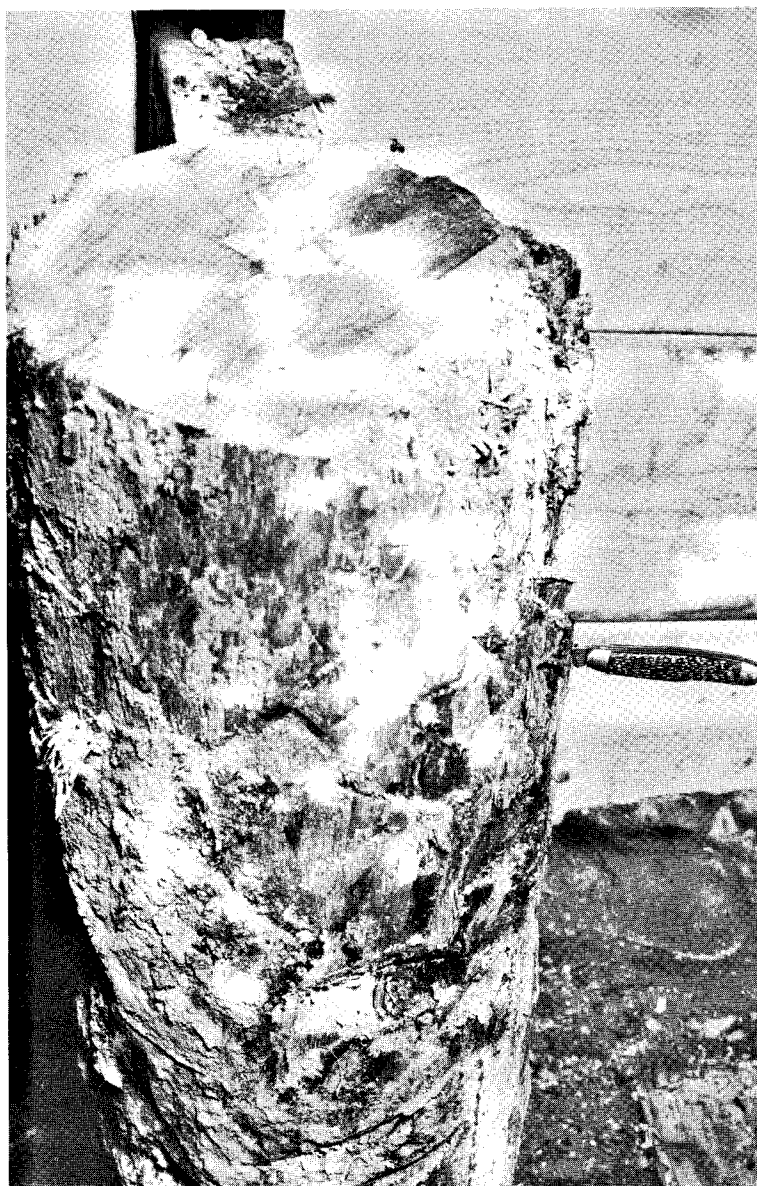
THIS untreated oak pile failed because of decay above ground water level after 17 years in the foundation of a building of The Dow Chemical Co. at Midland, Michigan. The extent of decay is apparent from the cut-off and knife blade pushed in to its hilt.

Evidence of the serious decay to which untreated wood piles are subject was found recently when contractors removed a concrete floor while remodeling a metallurgical laboratory building of The Dow Chemical Company at Midland, Mich. Two 25-ft. red oak foundation piles were uncovered, cut off slightly below the existing water level and examined for decay as shown in the accompanying photographs. Tops of all the other piles involved in this remodeling also were found to be seriously decayed, although the wood below the water table was sound. These piles had been in place for only 17 years. Some of them were spaced four to six ft. apart and supported the foundation for heavy manufacturing equipment; others supported columns of the building. This laboratory was constructed hurriedly during World War II as a temporary project when properly pressure-treated piling was not readily available.

Similar surveys and reports are available for many parts of the country because of the drastic lowering of ground water levels in many industrial and agricultural areas during recent years, and foundation engineers are advised to consult them carefully, particularly if untreated wood piles are to be considered. Caution also should be exercised in determining the actual level of the existing water table because in some instances holes dug in cohesive soils at a construction site may collect entrained water which may be mistaken for the water table. If surveys and reports are not available, the safe course should be taken and no risks run. Pressure-treated-timber piles should be used.
